PUBLIC HEALTH ASSESSMENT

Mercer Rubber Company Site Hamilton Square, Mercer County, New Jersey

August 2, 2006

New Jersey Department of Health and Senior Services Public Health Services Branch Consumer and Environmental Health Services Hazardous Site Health Evaluation Program

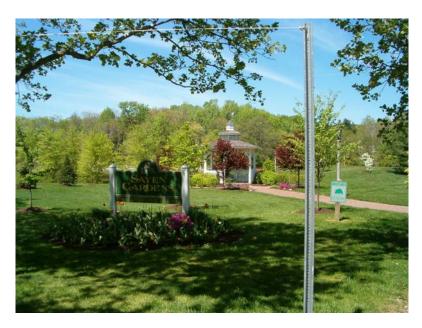
Photograph 1: Residences built on Mercer Rubber Company site

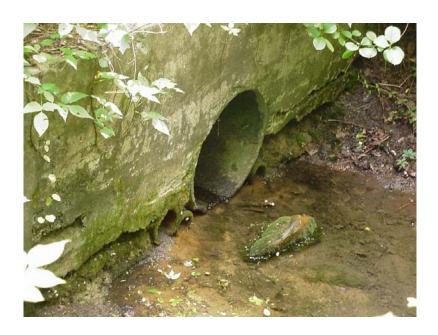
Photographs 4: Unnamed creek which flows into the Miry Run Brook

The soil at the site consists of fine, silty sand, fine sand with clay, and clayey silt. The topography of the site and the surrounding area is relatively flat (less than one percent grade). Groundwater depth is about 10 - 15 feet at the site. The unnamed creeks in the vicinity of the Mercer Rubber Company site flow through the community (see Photograph 4) and eventually drain into the Miry Run Brook located about one mile north of the site (see Figure 3). Based on regional topography, shallow groundwater was predicted to flow north (ELM 1995). Runoff from on-site paved areas either entered on-site storm drains or to a storm drain located in Mercer Street. The storm drain discharges into an unnamed creek; the unnamed creek flows along residential backyards and into the Miry Run Brook.

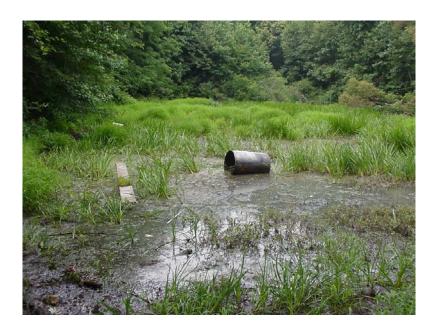
Photograph 5: Outfall pipes draining into the unnamed creek

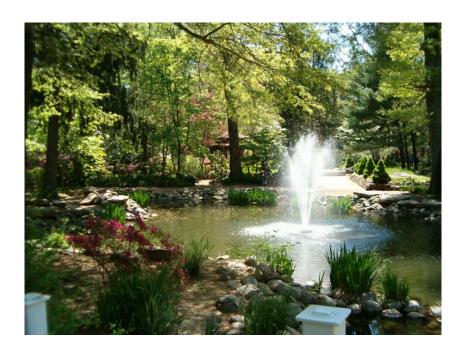
Photograph 7: Gazebo located adjacent to the Sayen House

gazebo and a second pond located to the west of the Sayen House were also observed (see Photographs 7 and 8).

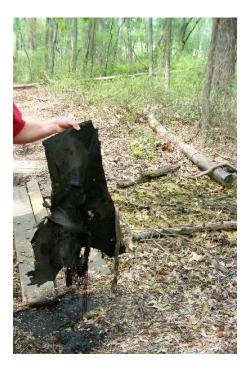
Photograph 9: The waste disposal area located approximately 500 feet to the north of the Sayen House
